ANCONEWS

SPECIAL EDITION 17 JANUARY 1994

Northridge Earthquake

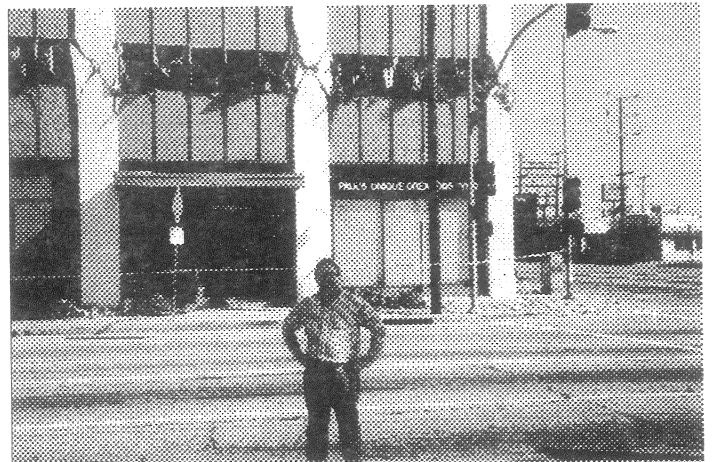
Figure 2 - Unusual 2nd story column failures resulted in building failure

In a strange juxtaposition, a modern six-story reinforced concrete office building, only a few hundred feet from the GERB houses, suffered major damage and was subsequently condemned

(see Figure 2). To our knowledge, this structure, at the corner of Barrington and Olympic, is the only modern high rise structure outside of the San Fernando Valley to sustain major structural damage. Within hours after the initial earthquake, ANCO engineers spotted the nearly uniform "X" type shear failures on the building columns between the second and third and third and fourth floors. Interestingly, failure did not occur in the first floor or higher floor columns. The building is asymmetrical in plan, had additional asymmetrical shear walls, and a central concrete utility core. ANCO believes that subsequent studies of this building design will yield important insight into critical design features that lead to lower than desired seismic capacity.

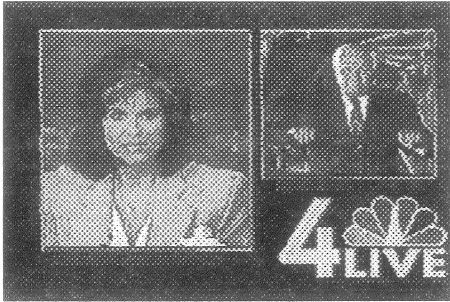
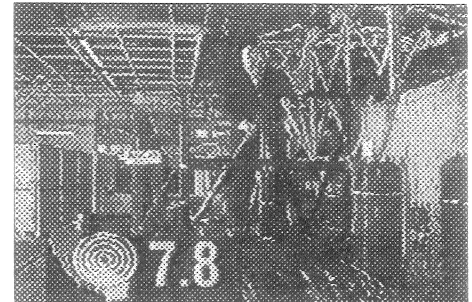
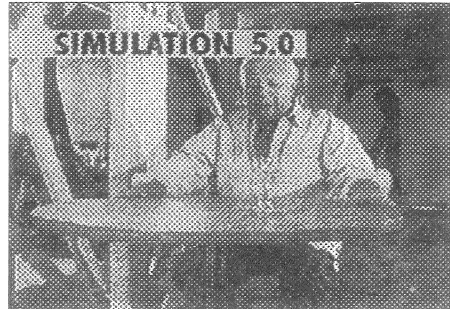
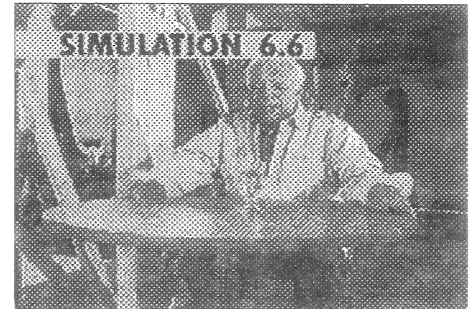
To both educate and calm local citizens who are unnerved by the continuing aftershocks from the January 17 Northridge earthquake, Fox KTTV Channel 11 television once again relied on ANCO's shake tables to show the effects of various magnitude earthquakes. David Garcia, a Fox TV reporter, sat through simulations of the main event aftershocks in a mockup of a dining area installed on ANCO's large R-4 overhead triaxial shake table (see above). Broadcast January 24, the simulations clearly illustrated for the public that aftershocks of magnitudes 3 to 5 would not cause the major property damage or injuries that occurred during the initial 6.6 earthquake.

Back in July 1993, limited video footage was available of the 7.8 earthquake in Northern Japan, Hokkaido. Three local TV stations (KNBC, KCAL, Fox KTTV) asked ANCO to provide immediate visual evidence for local citizens of the ground motion felt during a 7.8 earthquake. David Garcia, then with KNBC, was the first local reporter to show the public the impact of various magnitude earthquakes by riding through several simulations on ANCO's R-5 triaxial shake table, including a simulated 7.8 quake, during live TV news broadcasts from ANCO's Culver City laboratory. Barbara Schroeder from Fox KTTV also included live interviews with Paul Ibanez, ANCO's Presi-
